1 “Vertical Root Fractures: A Comprehensive Review of Diagnosis, Etiology, and 2 Management.

4 Vertical root fracture (VRF) is a longitudinal fracture of the root that most frequently affects endodontically treated
5 teeth, although it may also occur in vital dentition. As part of the cracked tooth spectrum, VRF presents significant
6 diagnostic and therapeutic challenges due to its variable clinical manifestations and its resemblance to persistent
7 endodontic or periodontal disease. The etiology is multifactorial, involving natural predisposing factors such as root
8 morphology, occlusal loading, dentin aging, and pre-existing microcracks, as well as iatrogenic factors including
9 excessive dentin removal, obturation stresses, post placement, and inadequate restorative design. VRFs typically
10 develop through a slow process of cyclic fatigue and structural weakening of radicular dentin, leading to
11 longitudinal crack propagation and subsequent periodontal breakdown.

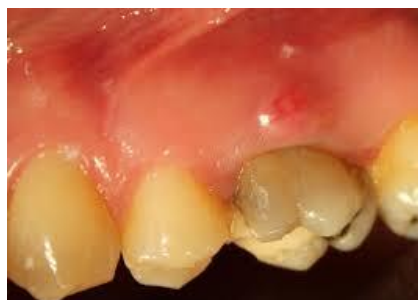
FIG 1 - A draining sinus tract at the gingival margin of a first maxillary molar with a buccal VRF in the mesial root.

212 Coronally located sinus tract. Sinus tracts that originate from a chronic apical abscess are typically detected at the
213 site of least bone resistance, against the apical part of the root or in the area of the junction of the attached gingiva
214 and the oral mucosa. Sinus tracts that are associated with a VRF pocket are often found in or close to attached
215 gingiva rather than in the apical region as the source is not from a periapical lesion (Fig 1).² Double or multiple sinus
216 tracts are common (Fig 2). Where multiple sinus tracts are present one or more of these tracts may be located some
217 distance from the involved tooth.⁸ Thus, the insertion of a gutta-percha point into the sinus tract to trace the
218 offending tooth assists in diagnosis. If the gutta-percha cone appears parallel to the periodontal ligament (PDL), a
219 VRF is highly suspected. This unique tracing pattern provides an important diagnostic difference between a VRF

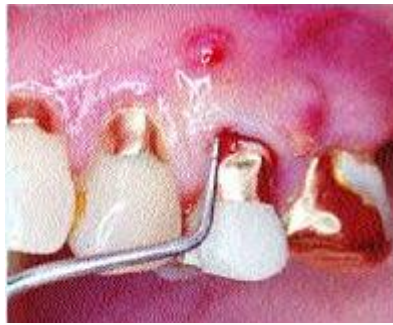
FIG 2 - Double or multiple sinus tracts are a feature of vertically fractured teeth.

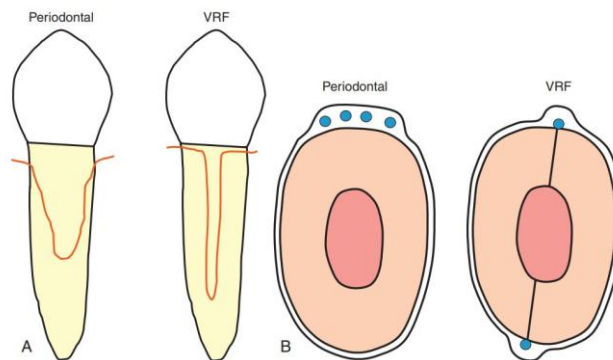
FIG3 - Vertical root fracture (VRF) pocket. A, Periodontal pockets (left) are wide coronally, whereas VRF pockets (right) are narrow and deep. B, Periodontal pockets (left) are loose and allow probing at various sites, whereas VRF pockets (right) are narrow and tight. If not checked carefully at every millimeter of the sulcus, an early VRF pocket can easily be missed. Note that periodontal pockets appear more commonly in the proximal sides of the root, whereas VRF pockets are more common on the buccal or lingual sides.

233 A common feature of vertically root fractured teeth is the development of deep, narrow, isolated periodontal
234 pockets. Pocketing is usually situated adjacent to the fracture site (FIG 3).⁸

237 Vertical root fracture pockets. The pockets that are typical of the early stages of VRFs differ substantially from the
238 deep pockets associated with advanced periodontal disease. The deep pockets associated with periodontal disease
239 develop as a result of the bacterial biofilm that initially accumulates at the cervical areas of the tooth and the
240 destructive host response to these bacteria. Therefore, deep periodontal pockets are typically wider coronally and
241 easier to probe. This pocket anatomy allows an easy insertion of a rigid periodontal probe. These types of
242 periodontal pockets typically present with the deeper part of the pocket at the mesial or distal aspects of the tooth. In
243 addition, periodontal disease often affects groups of teeth rather than an isolated location of a single tooth.

244 The pockets associated with VRFs develop due to bacterial penetration into the fracture, triggering a destructive host
245 response that occurs in the periodontal ligament along the entire length of the fracture. These bacteria may leak from
246 an infected root canal; however, when the VRF extends to the cervically exposed root, the microbes in the fracture
247 may also originate from the oral cavity. In the early stages, the periodontal ligament is affected and destroyed along
248 the longitudinal opening of the fracture, initially with a limited resorption to the adjacent bone. This permits the
249 penetration of a periodontal probe. The pocket associated with a VRF is typically isolated and present only in a
250 limited area adjacent to the affected tooth. This pocket is often located at the buccal or lingual convexity of the tooth
251 (FIG 4)

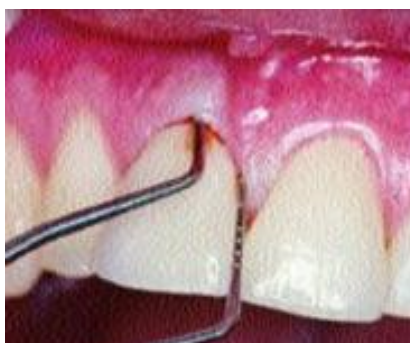
FIG 4 - Maxillary central incisor tooth exhibiting a deep narrow pocket on the labial surface of the tooth with normal attachment in the interproximal area. The presence of a bucco-lingual vertical root fracture was confirmed by surgery.

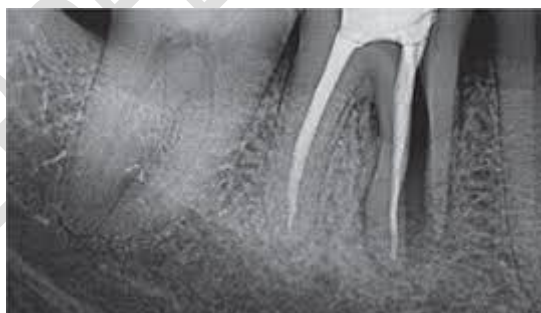
283 When separation of root fragments occurs, the root fracture is clearly visible. Once separation of fragments has
284 occurred, proliferation of granulation tissue often results in the rapid movement of the fragment away from the
285 remaining root, in many cases until the fragment comes into contact with an adjacent tooth.⁸

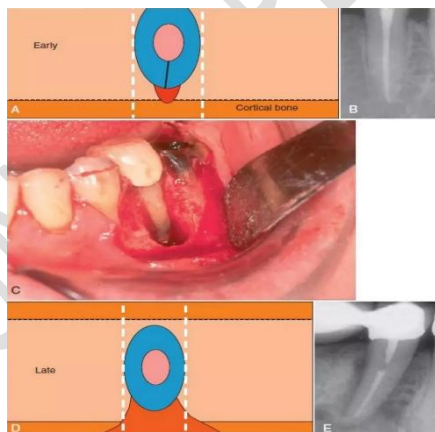
Early versus late radiographic presentation of a vertical root fracture-associated bone defect. At an early stage, a bone defect (red) is not likely to be detected in a periapical radiograph, as the root will overlap with the defect (A and B). At later stages, when major damage has occurred to the cortical plate (C), the bone defect may be large enough to extend beyond the silhouette of the root (C and D) and appear as a radiolucent defect along the root (E)

320 The type of periradicular radiolucency associated with a VRF is not and should not be interpreted as a thickening of
321 the PDL. Instead, it represents a substantial destruction of the cortical plate of the alveolar bone. In the case of a
322 VRF in the bucco-lingual plane, often the bone resorption is limited at early stages, and any associated radiolucency
323 may be obscured by the superimposition of the root. As the bone loss increases, the radiolucency becomes greater
324 than the dimensions of the root, allowing it to be detected more clearly.²
