1 Rethinking the Effectiveness of Floor Markings, Machine Guards, 2 and Safety Signage in Shaping Safer Work Environments.

7 This study examines the effectiveness of workplace safety interventions through a qualitative
8 embedded case study conducted in a high-volume manufacturing environment. Focusing on
9 three key interventions: floor markings, machine guards, and safety signage, the research
10 investigates how these measures influence not only hazard control but also worker behavior,
11 perception, and decision-making. The case is situated within a bottling hall setting, where
12 multiple operational risks, including pedestrian–vehicle interactions, machinery hazards, and
13 chemical handling, are present. A key contribution of the study is the development of new
14 internal standards for exclusion zone floor markings in the absence of existing organizational
15 or national guidelines. These bespoke markings, including innovative pacemaker-specific
16 warning zones, represent a novel approach to integrating inclusive and context-specific safety

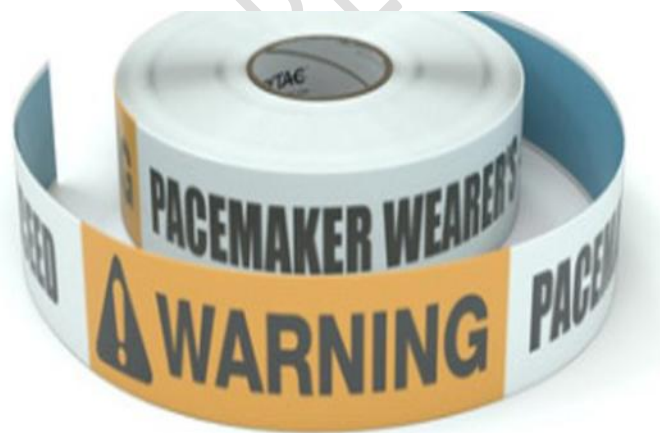
378
379 **Figure 1.** Pacemaker warning tape

367 A central innovation of this HSE project was the development of new internal Diageo
368 standards for floor markings to delineate exclusion zones and safe distances, particularly
369 between production Lines 3 and 4. In the absence of any pre-existing internal Diageo or
370 British standards for such markings, the researcher designed and implemented high-visibility
371 floor tape suitable for warehouse traffic. This included the incorporation of specialised
372 warning tape targeted at pacemaker wearers (see Figure 1). The tape, featuring bold
373 “WARNING” panels and “PACEMAKER WEARERS” text, serves to create clear visual
374 barriers around equipment that may emit electromagnetic fields, thereby protecting workers
375 with active implanted cardiac devices. These bespoke markings go beyond generic spatial
376 organisation by integrating specific health-risk communication directly into the floor

377 environment, enhancing both visibility and inclusivity of the safety controls.

471 Among the most immediate and obvious effects of the interventions was the significant
472 enhancement of the spatial awareness and the movement control throughout the bottling hall.
473 The implementation of easily recognizable floor markings and exclusion zones helped to
474 considerably decrease the level of ambiguity in high-stakes zones, especially the ones where
475 pedestrian traffic collides with the work of forklifts. It was noted that workers tend to move
476 in specific directions more regularly, and less often move disorderly or enter dangerous areas.

485 It was also noted however that the effectiveness of these markings would probably rely on the
486 sustained visibility and periodic reinforcement. Wear and tears can lead to the loss of clarity
487 in high-traffic locations with time, and therefore, their behavioral effect might diminish
488 unless there is proper maintenance [38].

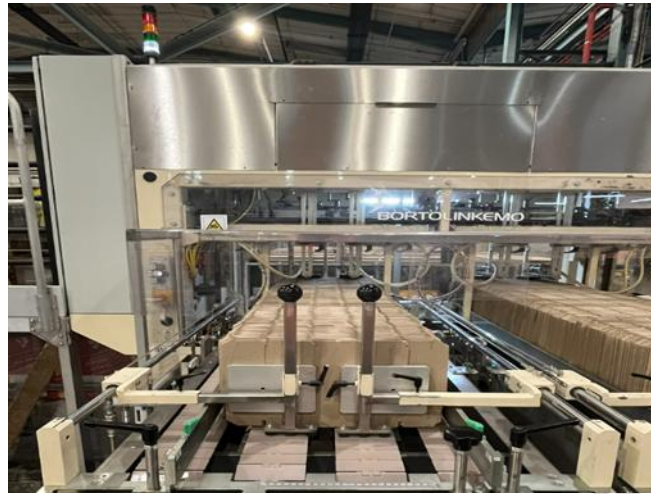
390
391 Figure 2. Div-Inserrer and associated packaging machinery

381 The project included the design, testing, and implementation of an improved safety guard for
382 the Div-Inserter and associated packaging machinery. As shown in Figure 2, a transparent
383 polycarbonate guard was installed on the Bortolin Kemo machine to enclose hazardous
384 moving parts while allowing clear visibility of the packaging process. This engineering
385 control was subjected to testing and validation following prototype approval. The guard
386 incorporates safe distances, interlocks, and ergonomic access features, supported by newly
387 developed work instructions and a reviewed risk assessment. Full guard replacement across

388 all relevant lines remains a key next step in the project plan, aimed at consistently elevating
389 the level of physical protection beyond minimum compliance requirements.

489 Moreover, the application of better machine guarding provided significant gains in direct
490 reduction of hazards. The polycarbonate guards installed successfully surrounded moving
491 components of the Div-Insertor and related equipment and reduced the chances of accidental
492 contact whilst maintaining a view of activity. This safety and usability strike is paramount
493 because over-constricting designs tend to cause non-adherence to or workarounds [35].

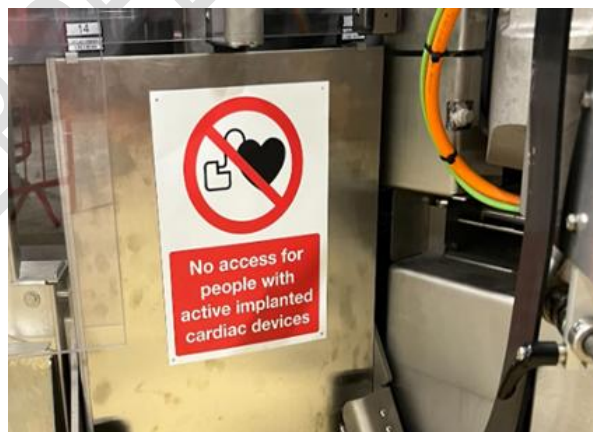
401
402 Figure 3. Safety Signage

393 Figure 3 shows a prohibition safety sign affixed to industrial machinery (near electrical or
394 magnetic components, given the visible wiring and stainless-steel housing). Enhanced safety
395 signage was rolled out across the bottling hall, including QR codes for easy access to Safety
396 Data Sheets (SDS), COSHH-related warning signs, and specialised prohibition signs. A
397 notable example is the installation of ISO 7010-compliant signage warning against access for
398 people with active implanted cardiac devices (see Figure 3). This measure addresses potential
399 electromagnetic interference from machinery, reflecting a proactive approach to
400 accommodating diverse worker health profiles beyond standard regulatory requirements.
